FINAL REPORT
DEMONSTRATION OF 156 INCH MOTOR WITH
SEGMENTED FIBERGLASS CASE AND ABLATIVE NOZZLE

VOLUME II--STATIC TEST AND HYDROBURST (U)

December 1968

THIOKOL CHEMICAL CORPORATION
WASATCH DIVISION
Brigham City, Utah

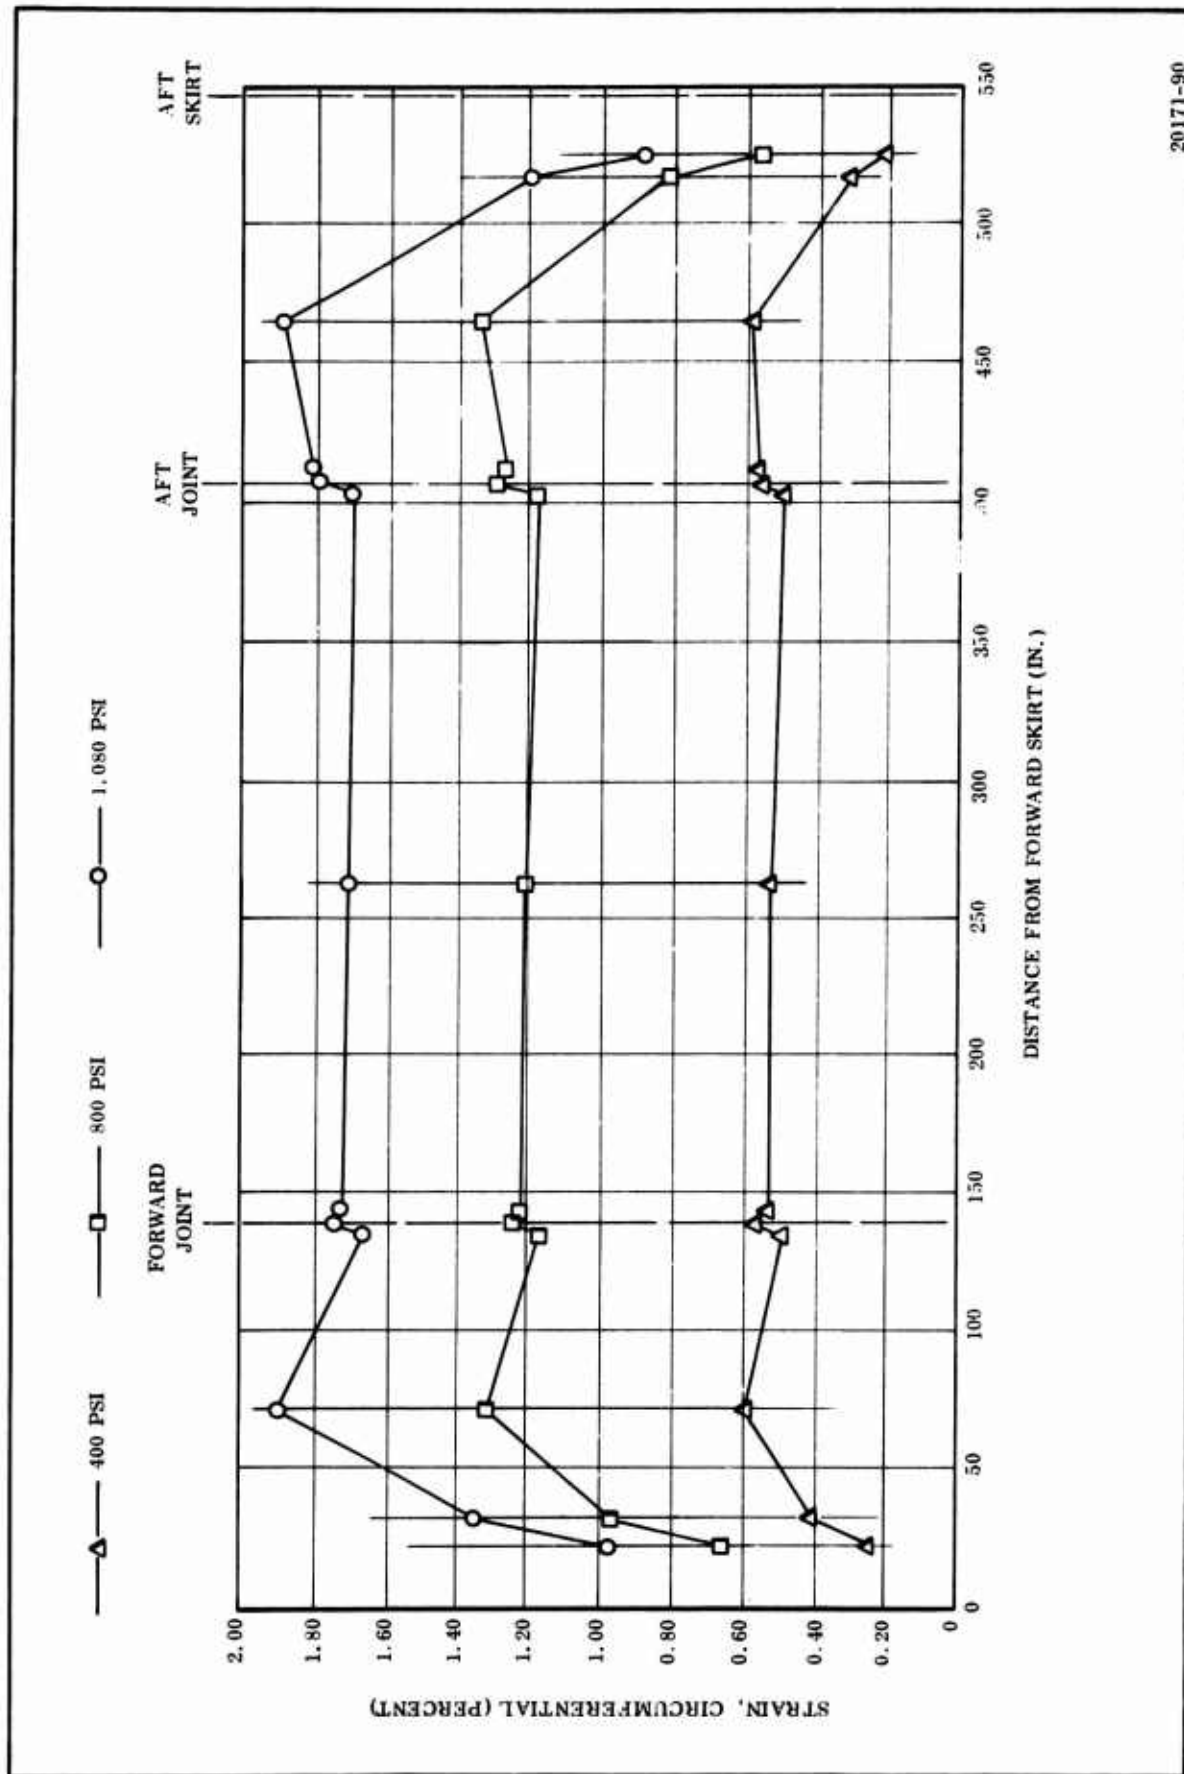
(U) Figure 55. Circumferential Strain Data

(U) Hoop strain data at various case locations is plotted in Figure 55 for three different pressures. Strains have the same pattern as those of the third 156-8 hydrotest, but the strains from the hydroburst are about 7 percent higher. The change in strain at the joint was investigated to determine if it had an effect on the forward segment failure. The discontinuity stress at the joint induced by varying hoop stiffness would only increase the axial stress 4 percent. A 4 percent increase in axial stress did not have a significant effect on the forward segment failure.
